**Assessing the state, impact, and sustainability of the Vunania and Gia reservoirs in the Kassena
Nankana Municipal of the Upper East Region**

A report by the Peasant Farmers Association of Ghana

2023

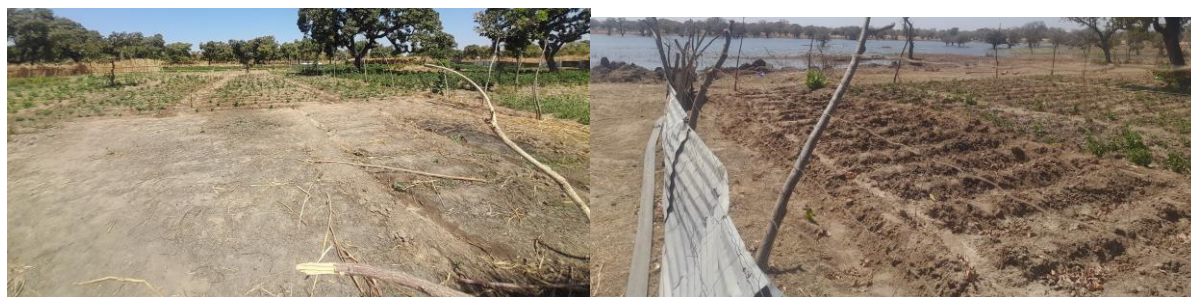
Plate 1 Irrigation farming at the upstream area of the Vunanai dam with some farms sited too close to the reservoir

Unfortunately, some of the farms were sited too close to the reservoir (Plate1-left) and that can result in rapid sedimentation of the reservoir, leading to a further decrease in reservoir storage (Atulley *et al.*, 2022). Hence, the reservoir buffer should be grassed, and farming prohibited within the boundary to curtail sedimentation.

It was also observed that some of the farmers who started farming around the reservoir are too close to the water body and that can expose the reservoir to a high rate of sedimentation. It is therefore recommended that the buffer zone should be highly respected.

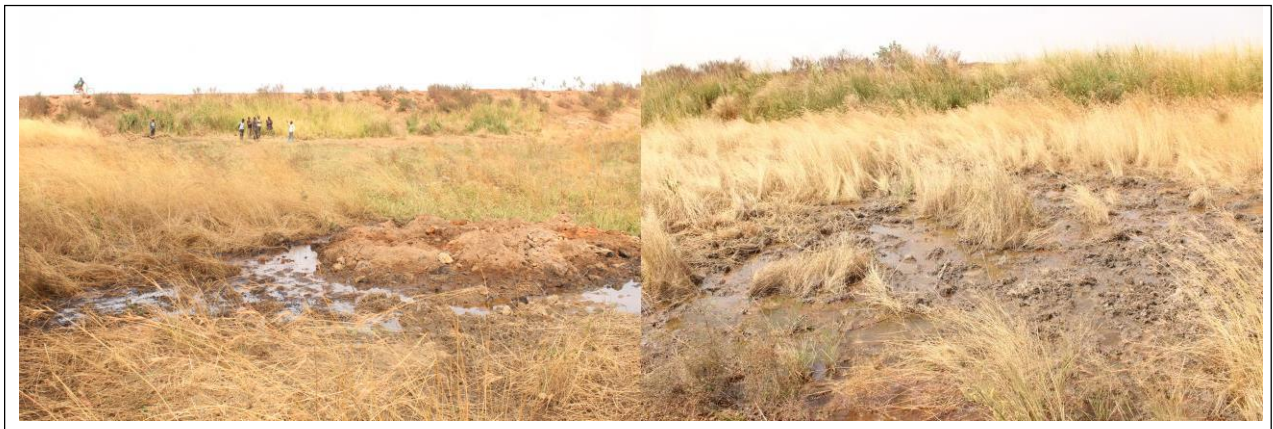
Plate 2. Water oozing out of the ground a distance away from behind the Vunania dam

Water was observed coming out from the ground at both ends behind the dam wall. The water was so much that it could be seen virtually running gently on the surface (Plate 2). Hence, the ground is wet even up to a mile away from the location. The community members are particularly worried about this situation because it means much of the water will be lost which could have been put to profitable use. The community members attribute it to seepage from beneath the toe of the embankment, which is a result of inadequate compaction of the foundation layers. The Assembly man stated that;

According to the GIDA field engineers, inadequate compaction of the dam wall layers cannot be ruled out as a possible cause of the water oozing out of the ground but also added, they strongly suspect two main causes of the challenge:

“The reason why my first suspicion is the porosity of underlying geological formations but not seepage through the dam wall is that; there are heaps of gravel at both upstream ends of the embankment area, which is an indication of the possibility of porous rock formation beneath the seeping location. Hence, the porous nature of such rocks allows water to percolate, and then by virtue of the pressure of the impounded water, water is forced out from the ground at the back of the embankment through the pore spaces. Furthermore, seepage flow is usually turbid because the seepage force erodes fine soil/clay particles from the dam wall materials and washes them out resulting in the turbidity of the water. Meanwhile, the water coming out of the ground is clean and clear, indicating that it is not seepage flow. Additionally, the water is coming out from the ground 6 meters away from the dam wall, and examining the toe of the embankment, there are no signs of wetness at the back of the dam wall. All the same, the source of the defect needs to be identified and corrected”.

It is important to note that almost all reservoir have some seepage. This is because the water in the reservoir usually seeks paths of least resistance through the dam body and foundation and when there are pore spaces beneath the impounded area water will find its way out through these pores. The good thing about the Vunania dam is that there is a fine clay lining at the mid-reservoir portion. Also, assuming the water is a result of pore spaces in rocks underground, as the water percolate and escapes to the backside of the embankment, the pores will be blogged gradually with particles in percolating water as they settle and with time the water loss will reduce (see Pham *et al.*, 2013). Moreover, the water coming from the ground at the back of the embank is within the irrigable area so farmers with such plots will need very little or no watering for their crops, and at the end of the day, it serves the same purpose.

Though all stakeholders have different views regarding the cause of the problem, they all agree that the source of the defect needs to be identified and corrected. Ascertaining the source of the defect is the first step to solving the problem. Hence, the case must be investigated carefully, and application of the necessary remedies should be done early to prevent it from becoming serious. The following are recommended to unravel the cause of the problem;

- Drain dam and observe if there are cracks in the impounded area. If the area is covered with pure clay, the cracks will result in seepage. Also if its covered with pervious material such as sand, there is bound to be seepage. If it is purely clay then it should be mixed with small amount of other material and if it's sandy, a lining high in clay should be introduced.

- Conduct geotechnical diagnosis of the dam wall to ascertain if the compaction was well done. In-situ investigation is recommended but not the destructive geotechnical analysis as done on layer by layer during the construction phase.

Since water loss is meters away, possible seepage from the foundation, layers (beneath the heel of the embankment) can be minimized through the introduction of a cut off wall bellow the dam wall. The cut off wall is a deep trench dug along the upstream end of the embankment (heel) and filled with impermeable material such as clay and concert in some cases. This is the most recommended remedy because it reduces seepage through horizontal cracks, fissures and pervious seams in the foundation and it is also a long term solution.

It must be noted that the water coming out of the ground is towards the edges of the valley (close to both ends of the embankment). Hence, when the water recedes beyond that point, the effect may cease therefore before the month of January is recommended as the best time for effective diagnosis to

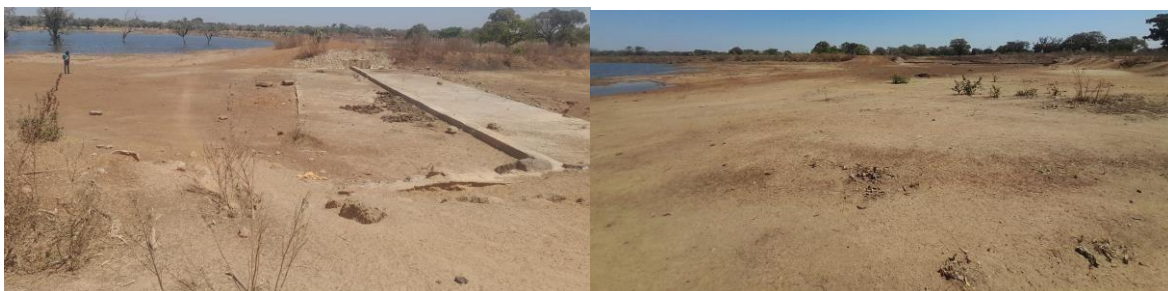
Plate 3. Spillway of the Vunanai dam and the high elevation of the impounded area leading to the spill

“In the second year, the dam impounded water so much to the extent that it nearly spilled over the main embankment, so the engineers quickly came and brook down the spillway for the water to go out. It has since been reworked on, but it is still high. Really if this project will meet its intended purpose sustainably, it needs to be thoroughly assessed and reworked on”.

Regarding the Embankment height, the GIDA engineers are of a different opinion. One stated that, *“The surface of the embankment is not uniformly leveled hence the contractors have to work on leveling the surface but regarding the embankment height, it is gone beyond the design height hence okay”.*

It is also recommended that the height of gravel heaped towards the spillway from the impounded area should be leveled.

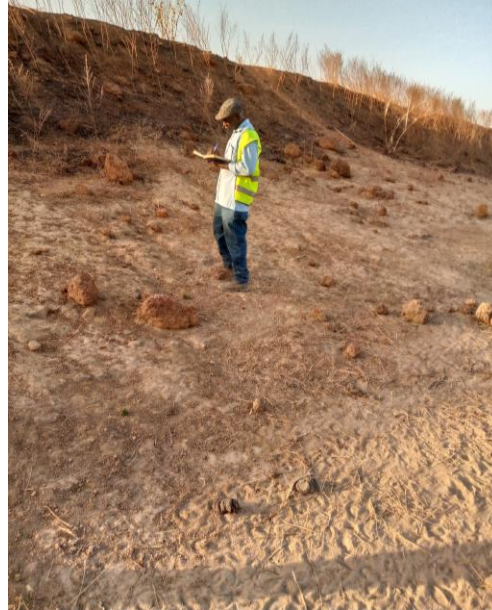
Plate 4. Undulating embankment

The embankment's undulating surface was noted, and it was found that downstream 1 in 2 was not fully applied during the dam wall process (plate 4). The residents of the community have indicated that the undulating surface is caused by car ties sinking after they have passed on the embankment. This is what a community member said.

“The effect of the undulation you are seeing on the embankment is that when the second contractor arrived to work on the irrigable area, his tipper truck carrying sand passed on the embankment and its ties sank a little”.

Downstream 1 in 2 not fully applied on embankment

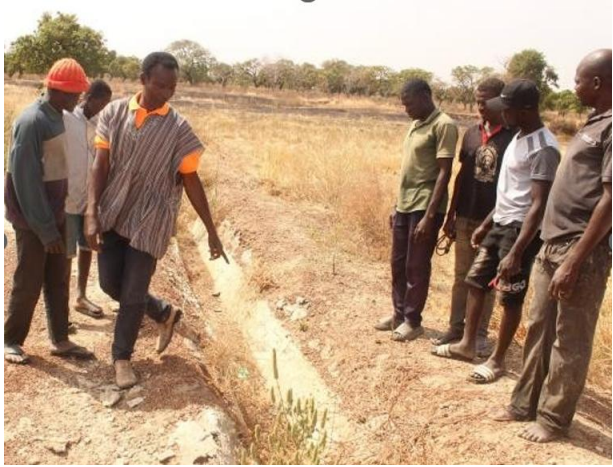
Plate 5. Breakages already at some portions of canals.

Shortly after the irrigable area was developed, some anomalies were also noticed there: i) Portions of the canal are broken and not entirely straight in some places (See Plate 5a); ii) nine leaks were found between the seven laterals along the main pipe line. iii) The offtake and lateral chambers appeared to have malfunctioning valves.

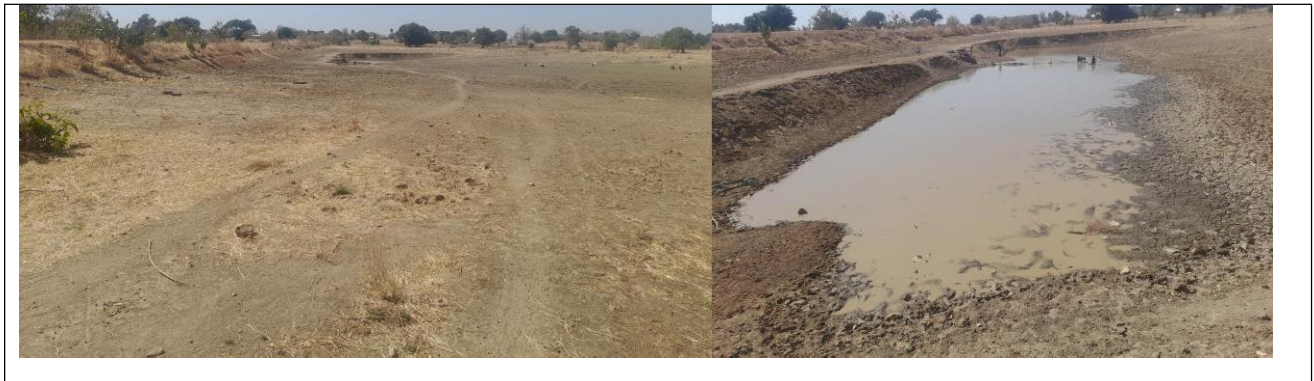
Plate 4: The Gia reservoir constructed in 2019 under the 1VID showing a flat valley with a pocket of water in the deepest part.

The Municipal and GIDA engineers also had this to say about the Gia Dam, *“The location of the dam is not suitable and the topography of the area is too flat for dam siting. They did not form any foundation to hold the wall (Key trench), they just heaped earth material on the bare ground to form a normal hill which they refer to as the dam wall. After constructing it, the water dried up immediately after the rains ceased. So the contractor went back and dug a steep pit towards the wall of the embankment to create room for more water. Because the pit does not have a gentle slope, when animals try to drink from it they easily get trapped”*.

Unfortunately, sedimentation has resulted in reducing the storage capacity hence now restricted to

According to the Engineers, it is possible to revive the Gia dugout

In the case of the Gia reservoir poor stakeholder participation resulted in poor execution of the project. It is recommended that rock boulders be used to line the dam walls and Vetiver grasses should be planted around the reservoir and behind the dam wall to trap sediment and help hold firm the dam wall material respectively. Also digging the other portions of the impounded area to the level of the highest depth will create room for more storage. Hence it is recommended that the Labour Intensive Public Works approach be used to uniformly increase the depth of the reservoir with a gentle slope.
